2024 ANNUAL BRIDGE REPORT

REPORT OF ROAD BRIDGE CONDITIONS

MASON COUNTY, WASHINGTON

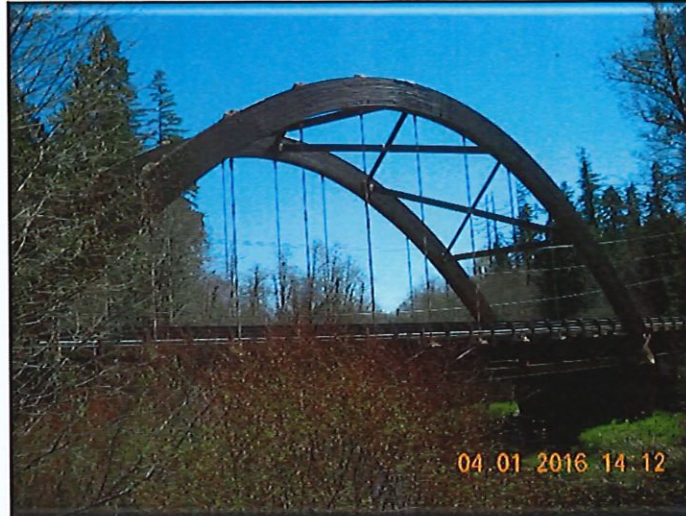
Eddy Evers, built 1996

Ever’s Bridge is a 354 ft multi timber span structure constructed in 1996. The middle span is a timber arch design. The protective coating has deteriorated and allows water intrusion. The arches have section loss and rot throughout the members. We have applied for but failed to secure grant funding to replace the timber arches with steel members.

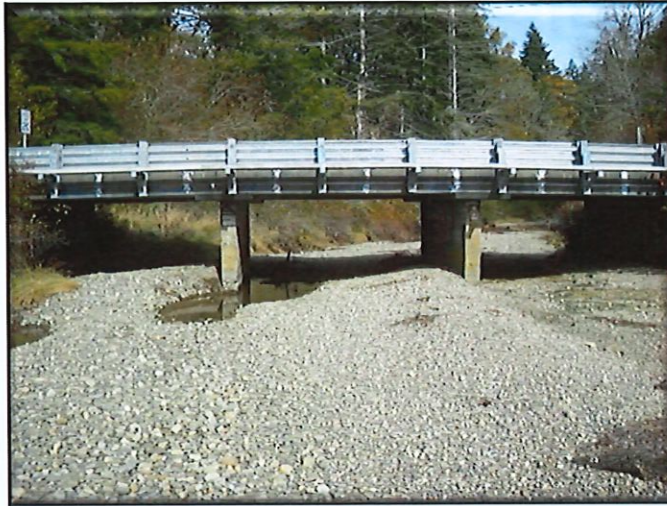
Rendsland Creek, built 1950

Rendsland Bridge is a 53 ft multi span cast in place concrete bridge constructed in 1950. The superstructure was replaced in 1973. Rendsland Creek flow of aggregate over time has caused erosion of the concrete pier walls at piers 2 and 3. There is loss of concrete and aggregate but no rust stains. These areas need to be repaired soon.

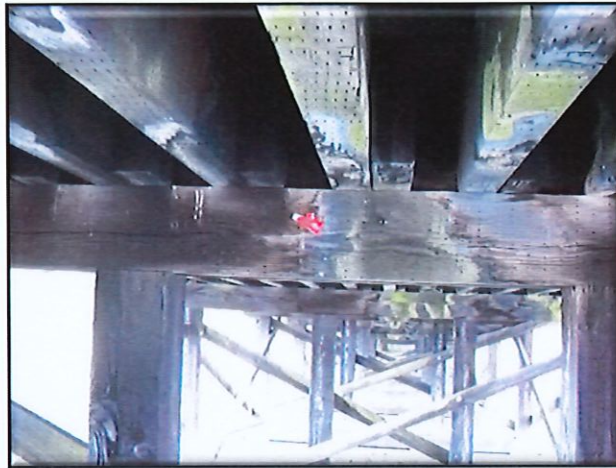
Stretch Island Bridge was constructed in 1952 and reconstructed in 1971. It has concrete piers with timber caps, post, stringers, and deck. There are various locations of rot in the timber members. Piers 1, 8, and 19 are spread footings and are scour critical based on calculations. This structure is the only vehicle access to Stretch Island. This structure will need to be replaced in the future.

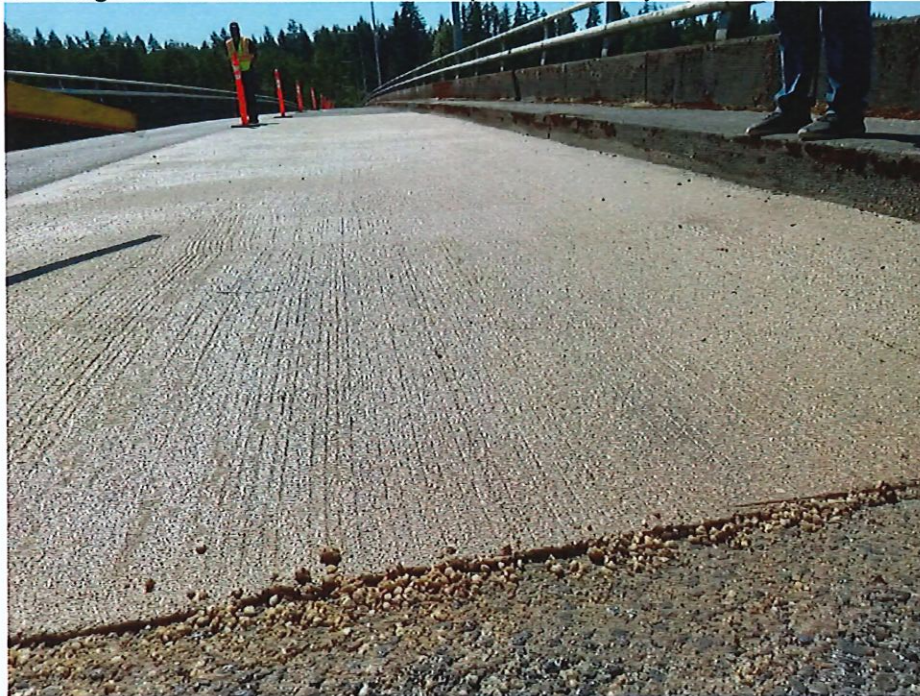
Harstine Island Bridge deck condition code 3. (currently being repaired)

Harstine Island Bridge was constructed in 1969 on concrete columns and superstructure. There are twelve locations on various columns that have delamination and spalling with reinforcing steel exposed and rusting. We have applied for but failed to secure grant funding. These will need to be repaired in the future.

Harstine Island Bridge pier one scour. Scour has caused rip rap to fail around the approach at pier one. There is a design and permitting in process to make repairs.

Harstine Island Bridge deck rehabilitation was performed by contract in the summer of 2023.
