2024 ANNUAL BRIDGE REPORT

REPORT OF ROAD BRIDGE CONDITIONS

MASON COUNTY, WASHINGTON

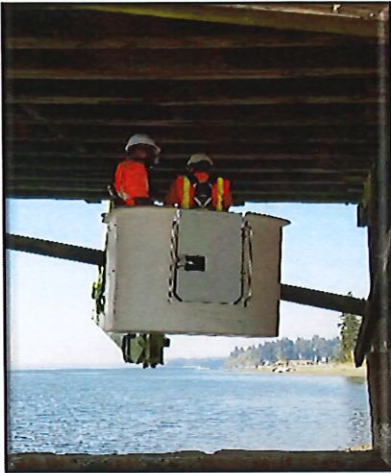
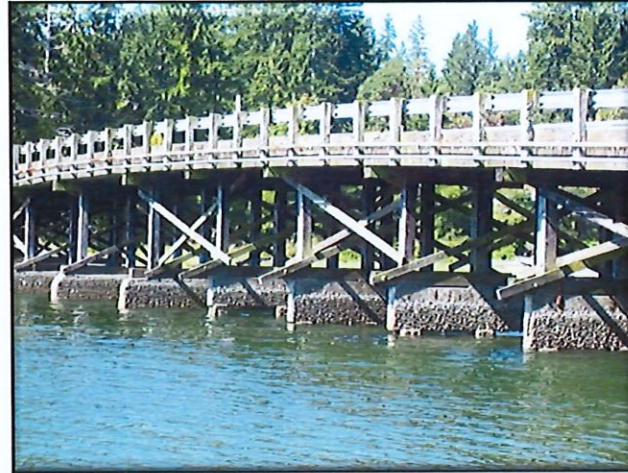
Stretch Island – 2022

Approximately half the bridges are inspected every other year. If the underside of the bridge deck cannot be given close or adequate inspection from the ground, then a special inspection using a UBIT (under bridge inspection truck) is required. During these bridge inspections, inspectors make an in-depth condition evaluation of the bridge structure and document any observable defects.
